# Ridge-to-River Trail Restoration

On steeper sloping sections of the trail where deer browse and human usage have left little or no vegetation to hold the soil, heavy rains have gouged gulleys and washed soil downhill over the years. To preserve the trail, save our soil, and restore plant life, the Rolling Ridge Conservancy implemented a trail restoration project on the most deteriorated portion of the Ridge-to-River Trail.

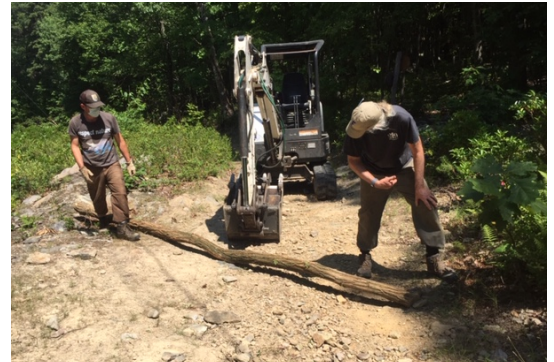
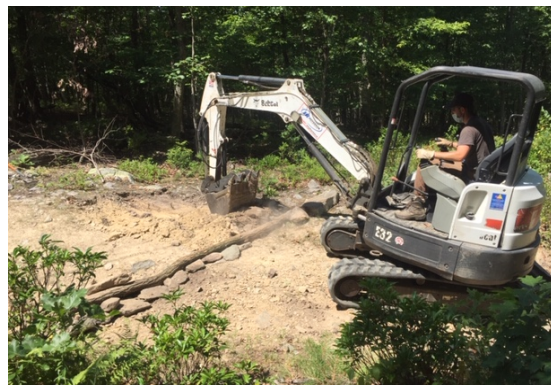
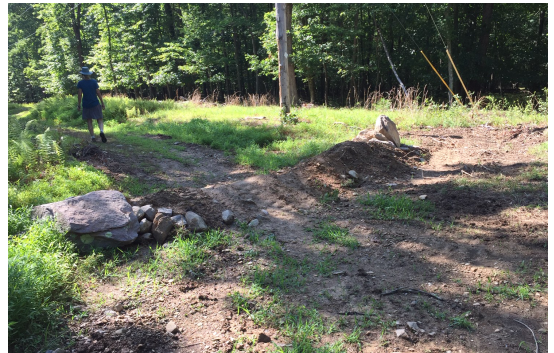
With the help of a generous grant from the Two Rivers Giving Circle (*part of the Eastern West Virginia Community Foundation*) and over 130 hours of hard work with dedicated volunteers and a rented excavator, RRC installed 22 water bars. Some of the larger bars have locust logs buried in them that were harvested on site. Water-worn ravines were filled with sediment-retaining rock to repair erosion damage. Dispersal areas and some open areas adjacent to the trail were seeded with a mix of warm season grasses and native wildflowers. Once established, this vegetation will hold the soil as well as providing cover and food for wildlife and pollinators.

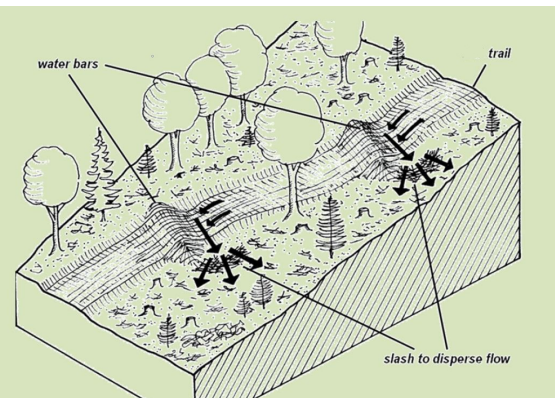
Water bars are raised berms constructed on a slight diagonal across the trail perpendicular to the path of the water. By interrupting the flow, water bars slow down and redirect storm-water off the trail into adjacent dispersal areas where water can percolate back into the ground along with the soil and silt that would otherwise wash away.
